Manhole Inspection Summary

Manhole # S35YY_007MH

Insp Date: **12/27/06 10:58 AM**

Location Address: **308 33RD ST**

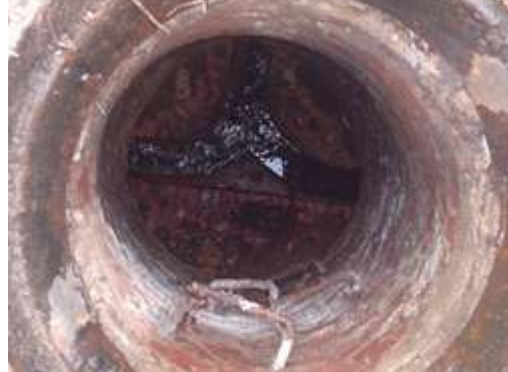
Top View

Corroded steps. Bench debris.

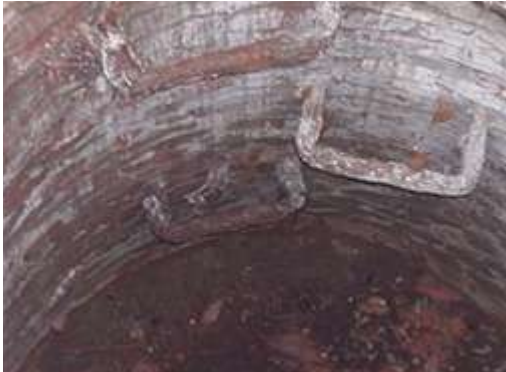
Defect

Barrel infiltration.

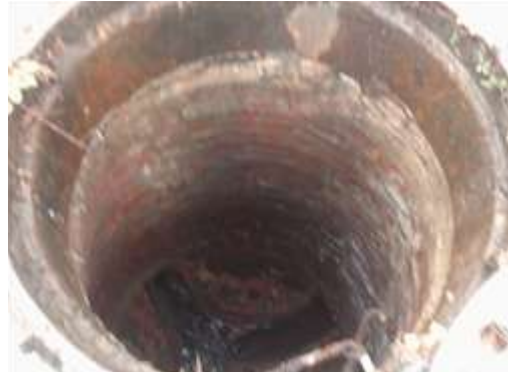
Defect

Frame leaks. Adjustment deterioration and infiltration. Barrel infiltration.

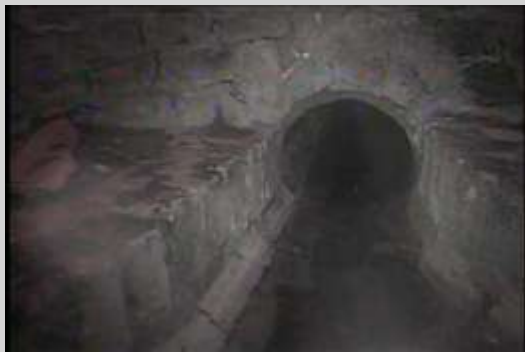
8 in. Circular Gravity Sewer Pipe Out @ 12 O'Clock

Infiltration: **Evidence** Pipe Seal Cond: **Cracked**

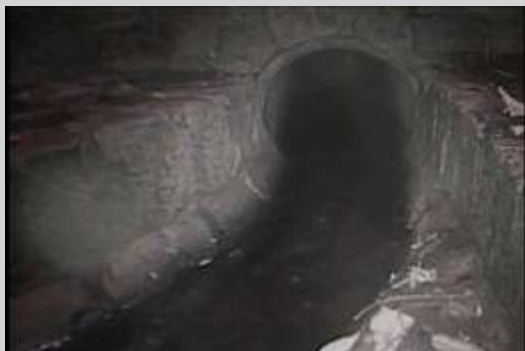
8 in. Circular Gravity Sewer Pipe In @ 3 O'Clock

Infiltration: **Evidence** Pipe Seal Cond: **Cracked**

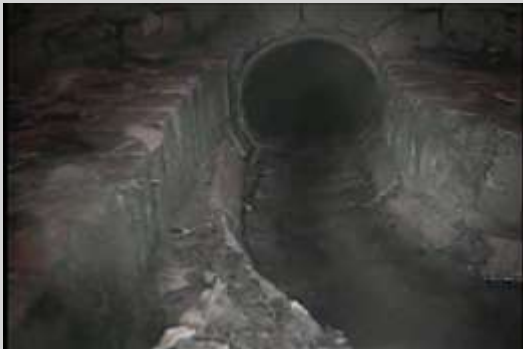
8 in. Circular Gravity Sewer
Pipe In @ 9 O'Clock

Infiltration: **Evidence** Pipe Seal Cond: **Cracked**
